# Steel rings corrosion free after 6 years

Lake Macquarie Transport Interchange Roundabout  
Lake Macquarie, NSW

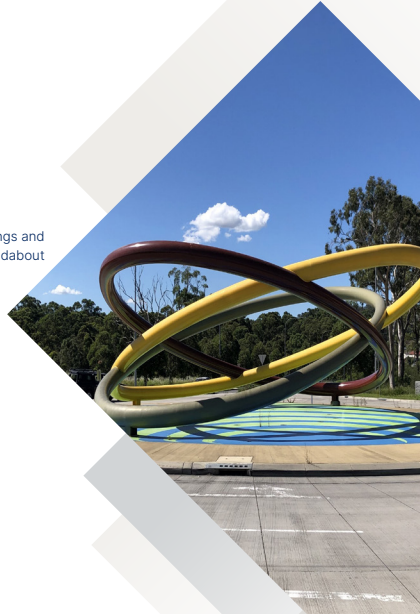
Steel rings and  
roundabout

The steel rings were still corrosion free after six years. There was some expected chalking and loss of gloss on the topcoat due to extreme UV exposure. For aesthetic reasons only, the colour could be updated with a clean and new topcoat.

Due to the high traffic environment, there was some ingrained dirt on the rings and roundabout surface. Regular cleaning of steel and concrete is also recommended but some dirt ingress is to be expected in this very heavily traffic environment.

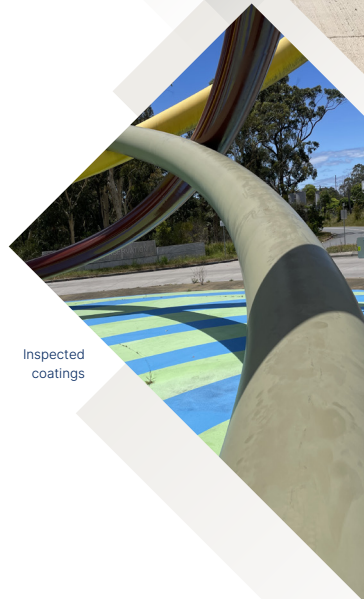
Inspected  
coatings

Level 2\*
