Level 1 rating for custom Cherry Red after 5 years

CityLink Red Sticks Melbourne, VIC

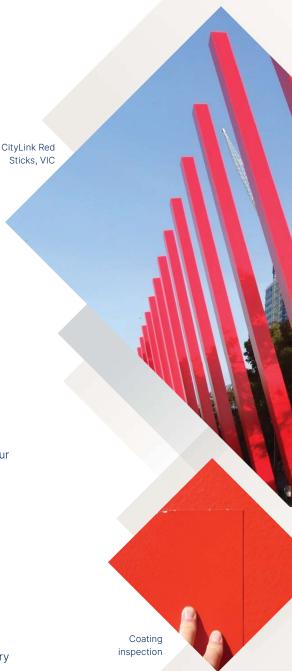
The assessment found the CityLink Red Sticks were in good condition. The custom Cherry Red colour was intact and the coatings were upholding their integrity.

Using the Delta E scale of 0 to 100, the change in colour was measured at a maximum of 2.5 on the UV-exposed north and west faces.
