# Rejuvenating Rating 1 after 4 Years for Ocean Bath Maintenance Cycle

Merewether Ocean Baths  
Newcastle, NSW

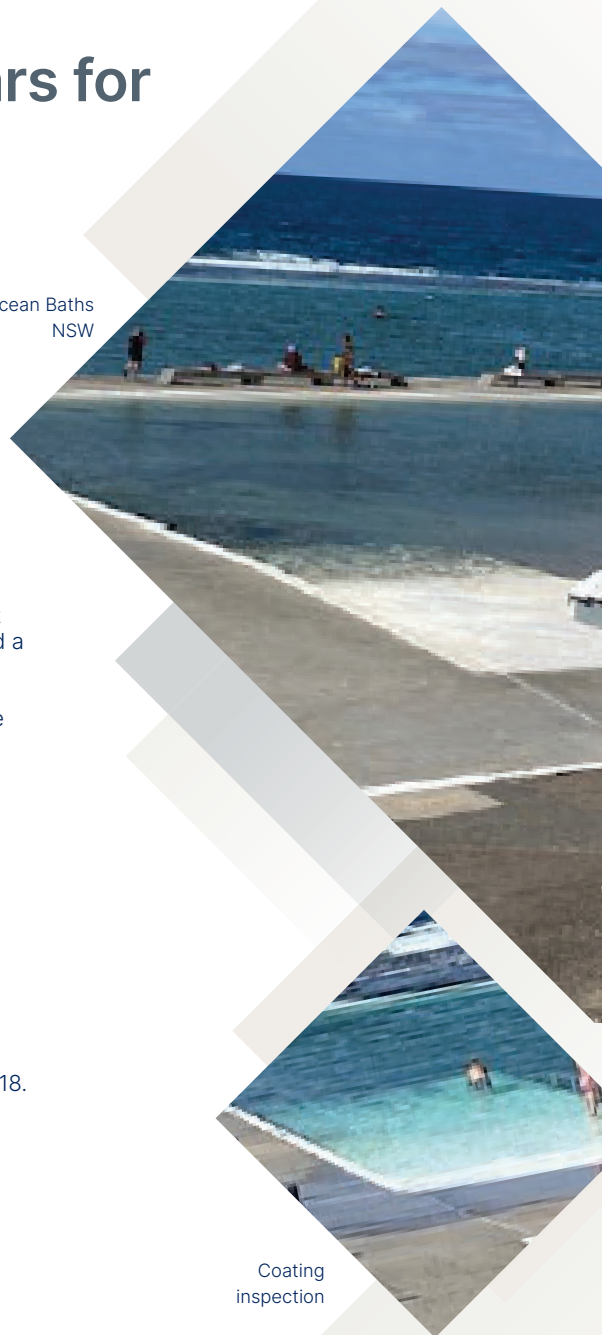
Merewether Ocean Baths  
NSW

Level 1\*

After four years, a visual inspection of the Merewether Ocean Baths concrete surfaces showed the coatings system to be performing as expected. The finish is in excellent condition and continuing to successfully inhibit algae growth, thereby extending the time between maintenance and reducing costs for the asset owners.
