## Problems with Concrete - Efflorescence

## 1.3.6

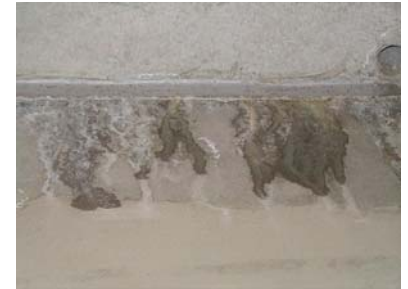
Efflorescence on concrete floor

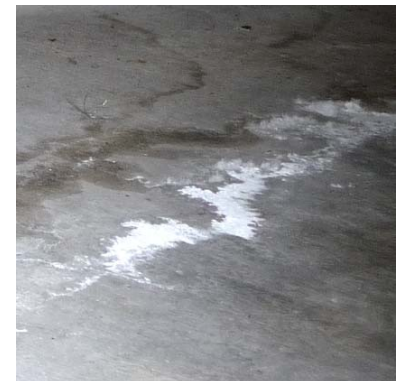
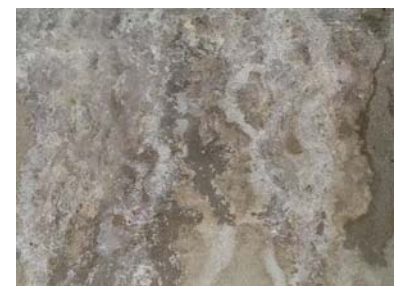
Efflorescence on concrete.
