# Concrete Floors – Tyre Staining

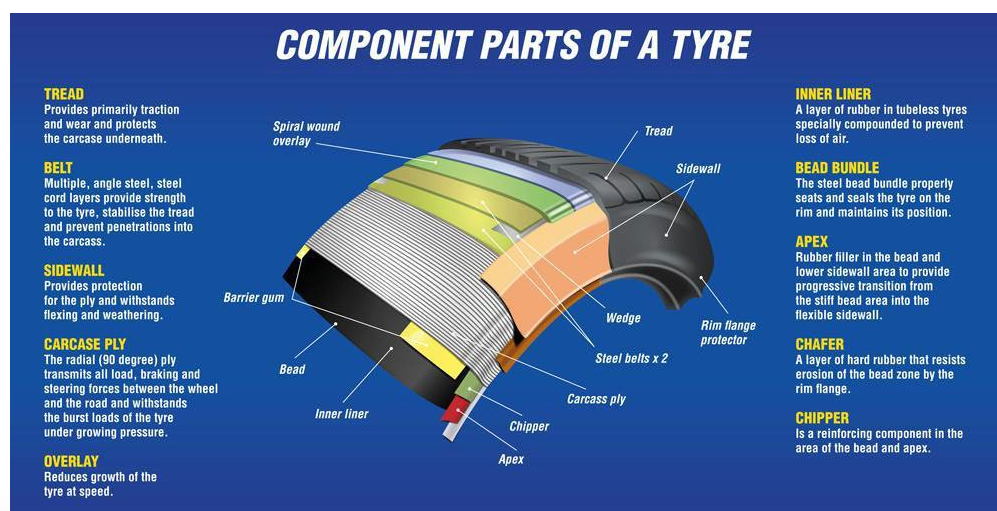
Tyre stain is usually due to the progressive release of one or more of the additives used in the formulation of the tyre tread. One common ingredient is called 6PPD<sup>1</sup>. Another is called IPPD<sup>2</sup>. Both 6PPD and IPPD protect the rubber from cracking and deterioration as well as providing temperature stability and resistance to flexure cracking. These are organic chemicals widely used as stabilising additives in rubbers, such as NR (natural rubber), SBR (styrene-butadiene rubber) and BR (butyl rubber); all of which are common in vehicle tyres. Although these are effective antioxidants, they are primarily used because of their excellent antiozonant performance. 6PPD and IPPD have been found to progressively migrate through the rubber matrix and onto the surface of the tyre where they react with ozone (O<sub>3</sub>) more readily than the ozone can react with the rubber. 6PPD has a slightly slower migration or leaching rate than IPPD, hence is favoured by some tyre manufacturers. Some tyre brands use both compounds. Once these materials leave the tyre and make contact with the floor coating, they oxidise, which is why the colour develops.

**Above:**  
An example of tyre stain on a coated floor. This shows a single-contact stain. Parking in much the same location over time will give a less defined pattern

The tendency of the tyre to stain the floor coating depends on the age of the tyre, the nature of the tread compounds, the duration of the contact, any temperature implication from the tyres, and the generic type, the state of cure and colour of the coating. Lighter colours tend to show staining to a greater extent.

There isn't anything a vehicle owner can do that will change the rate of progressive release of chemicals from the tyres that could cause staining. To minimise its visual extent, choosing floor colours in a darker shade will cause less contrast. Using mats or an impermeable sheet material in the position where the vehicle tyres will be when parked is another useful measure. Avoiding parking whilst the tyres are at elevated temperature and/or are wet after driving can also minimise staining.
