HDG – TROUBLE SHOOTING PAINT FAILURES

TROUBLE SHOOTING PROBLEMS WITH PAINTED HDG STEEL

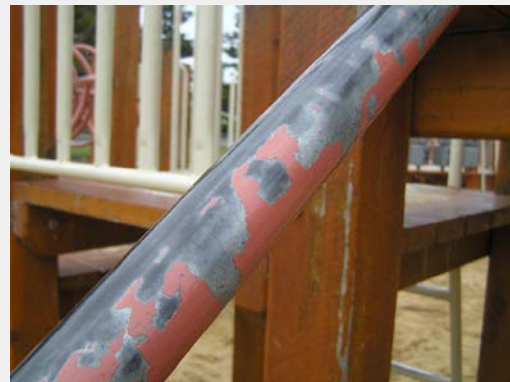
Underside of coating appears very smooth – little or no abrasion of the surface prior to painting

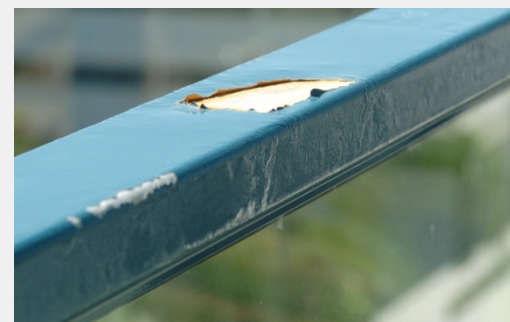
Inadequate coating thickness and humidity cause osmotic blistering

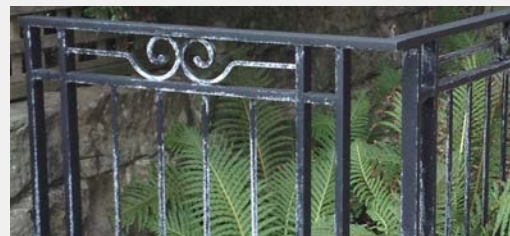
White rust appears on a micaceous iron oxide coating near a beachside residence.

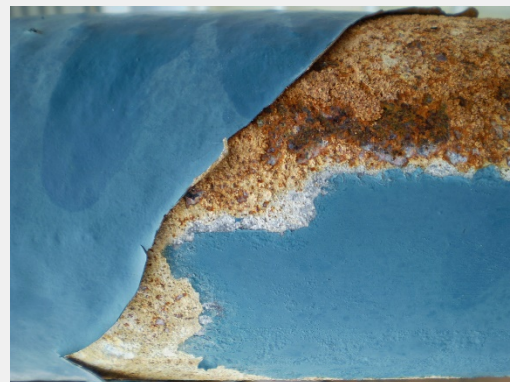
The aggressive coastal environment caused rapid zinc depletion on HDG in a coastal primary school.
