CONCRETE FLOORS – LAITANCE

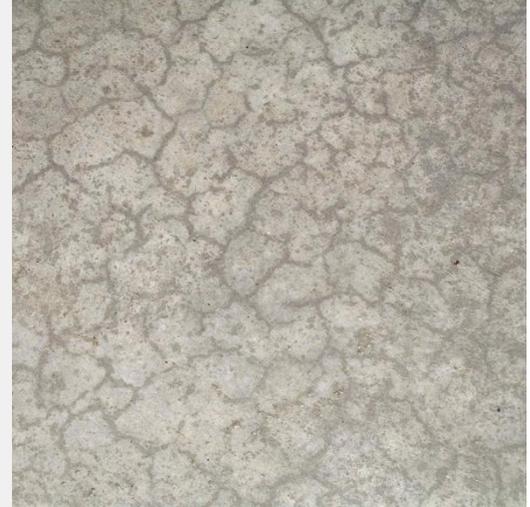
Laitance and shrinkage cracks

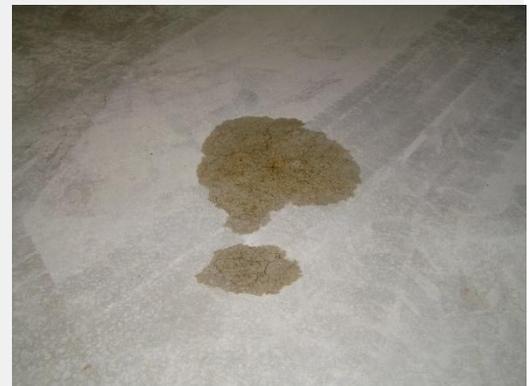
Oil stains and tyre marks on laitance-covered floor
