# HDG – PAINTING CONSIDERATIONS

## BEFORE YOU PAINT HDG STEEL

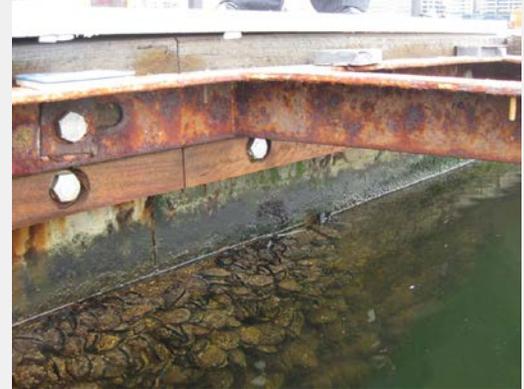
*Sacrificial corrosion protection at Docklands Landing after 6 years exposure is clearly inadequate.*

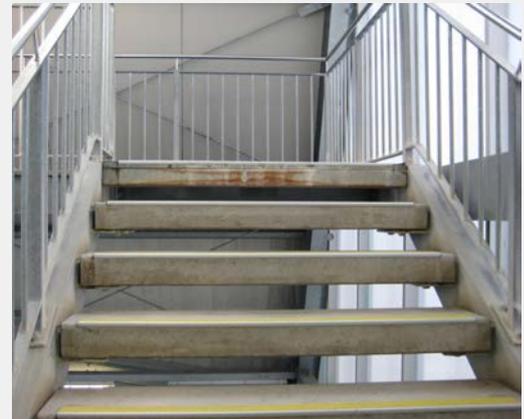
*Aquatic centres are extremely corrosive environments. This swimming pool steelwork was around 5 years old*

- Marine Exposure (salt, moisture)
- Chemical Exposure (acid, alkali, etc)
- Tropical Climate Exposure (Moisture)
- Indoor Swimming Pool Exposure (chlorine, moisture)

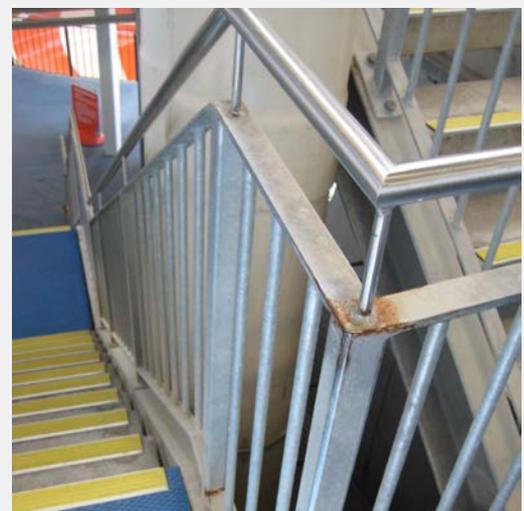
*Same aquatic centre; dissimilar metals must not be in contact with each other!*

- **Fixings** – if the fixing is of a different metal to the HDG steel and the two are in contact, then a resultant current will cause corrosion. A plastic isolator must always separate dissimilar metals. Some plastics can present paint adhesion problems. During application, paint can pool<sup>1</sup> around the base of the fixing and may cause excessive film builds and mudcracking<sup>2</sup>.

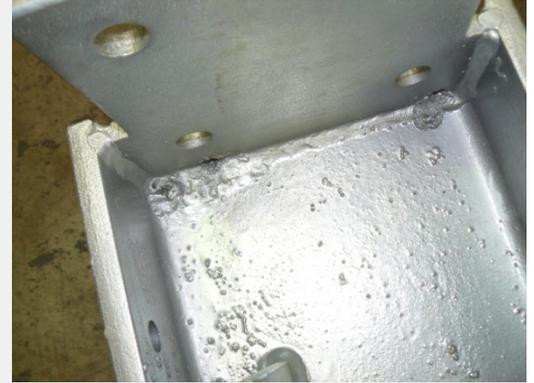
*This deep "U" section shows bubbles and brittleness of the HDG. Surface preparation and painting will be extremely difficult if the applicator accepts the work. Long term durability is very doubtful.*

- **Defects** such as air pockets and blisters in the HDG within the angles of the metal section are extremely difficult to detect if present.
- **Inaccessible sections** – sometimes sections are welded together in such a way that prevents access by brushes, rollers or spray units. Fixings can also reduce access of application tools.

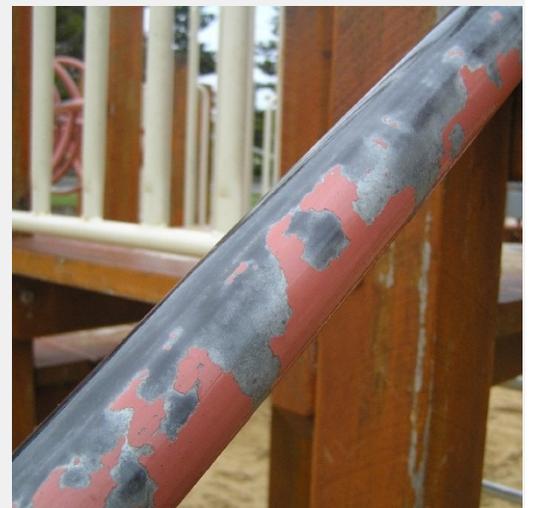
*The smooth surface should have been abrasive whip blasted prior to painting. Lake Pertobe playground Warrnambool Victoria*

- Insufficient abrasion – surface profile is not high enough for the coating system to key into, resulting in loss of adhesion.
- Dags/lumps of galvanising not removed – apart from the disappointing appearance of the painted steel, dags are often poorly bonded to the steel, and can simply drop off, particularly in response to steel expansion and contraction when subject to hot/cold temperature cycling.
- Acid wash – the traditional acid etching method of HDG steel would often result in traces of acid residues being entrapped under the coating system, causing deterioration of the galvanising layer and subsequent coating failure. Hence acid etch is no longer considered a viable method of surface preparation.

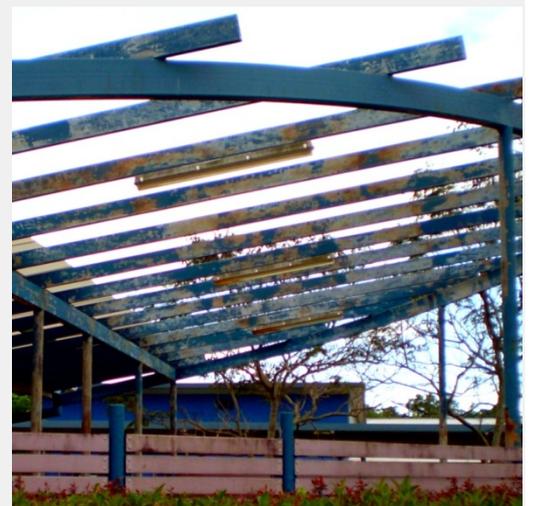
*Bentleigh Primary School Queensland enjoys bayside sea breezes, but the chloride-laden air accelerated the sacrificial corrosion mechanism of the five year old painted HDG steelwork*
