# Concrete Floors

## – Concrete Spalling

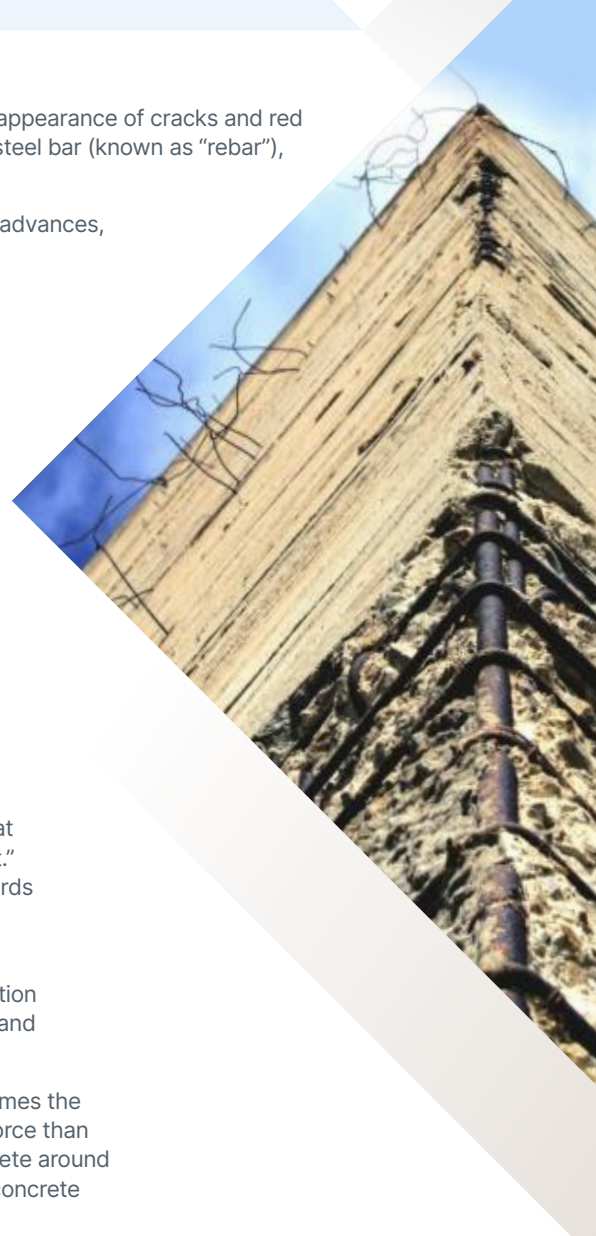
Whilst the oxidation-reduction reactions between iron metal, oxygen and water can get somewhat complicated, the simplistic equation below shows the oxidation process producing a very large and complex molecule of greater volume than the original iron metal.

When the embedded steel rebar corrodes, the corrosion products take up eight (8) times the volume of the original steel. This expansion within the concrete exerts a far greater force than the concrete's flexural strength will allow, resulting in cracks and spalling of the concrete around the affected steel. The cracks expose the steel to further corrosion leading to more concrete breakdown.

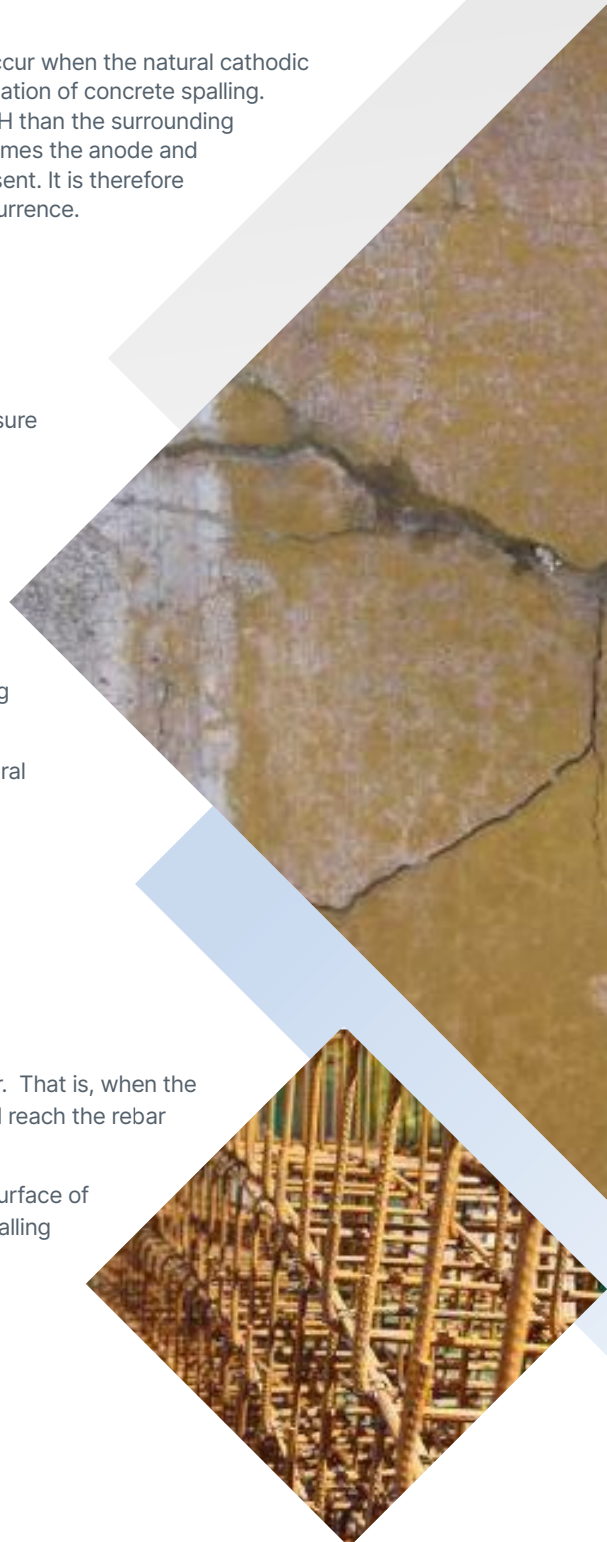
- Faulty concrete specification or design
- Incorrect placement of rebar and/or mesh, resulting in inadequate concrete cover. That is, when the rebar is placed too close to the surface of the concrete, the carbonation front will reach the rebar sooner, resulting in quicker concrete spalling.
- Poor site supervision during pouring, when the rebar is pushed too close to the surface of the concrete, as noted above, the closer the rebar is to the surface, the faster spalling can occur.
- Lack of a protective "anti-carbonation" surface coating to prevent ingress of acidic chemicals.
- Improper concrete repairs.
