Rating 1 rating after 7 years for external steel beams

Newcastle Museum
Newcastle, NSW

Newcastle Museum, NSW

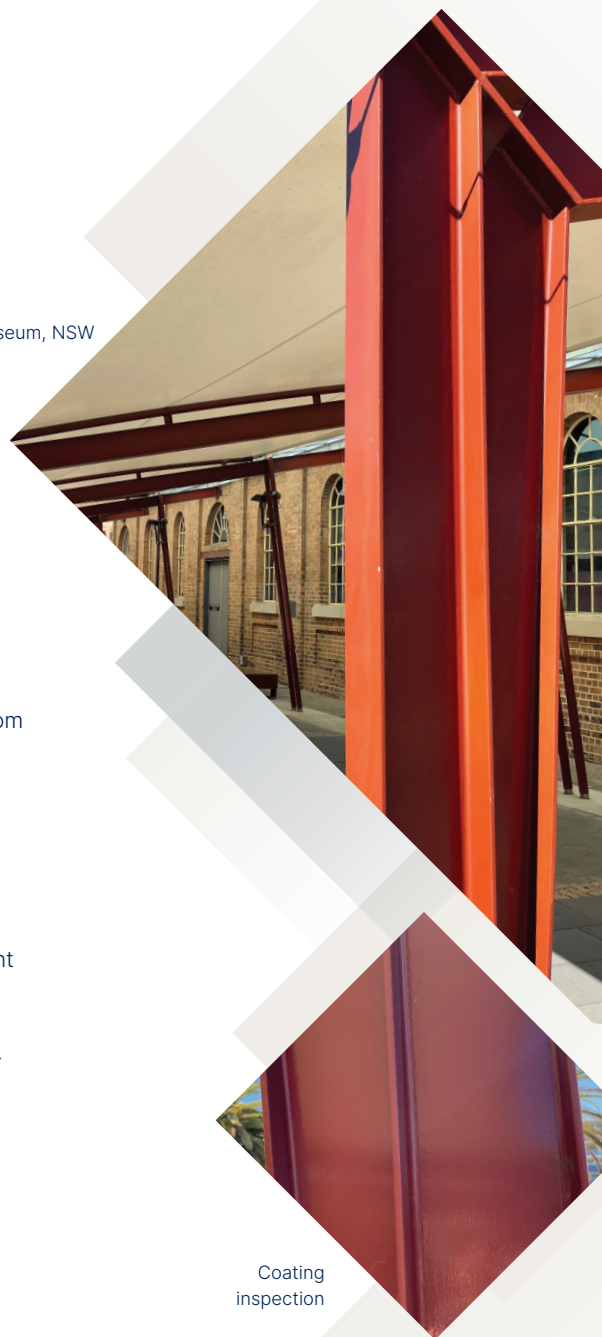
A full visual inspection at Newcastle Museum in 2023 found the archway beams coating system to be in excellent condition, seven years after the initial application in 2016.

There was no film damage and only a slight loss of gloss on some areas in direct sunlight.
