# CONCRETE FLOORS – EFFLORESCENCE

# CONCRETE – EFFLORESCENCE

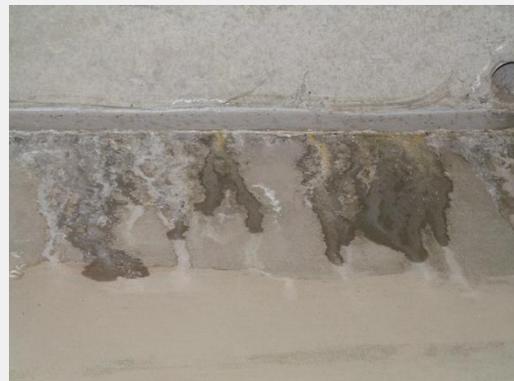
*Efflorescence near a floor joint*

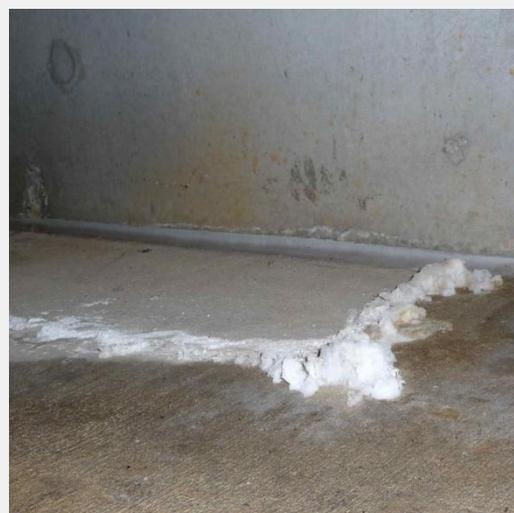
*Magnificent efflorescence near an external wall. A native garden and wetlands are nearby.*

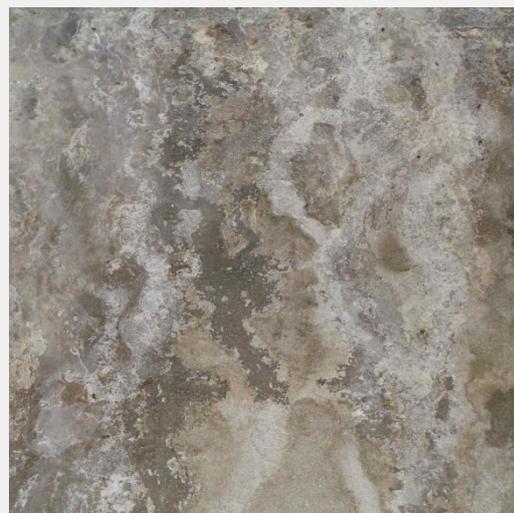
*Efflorescence can also appear on walls.*

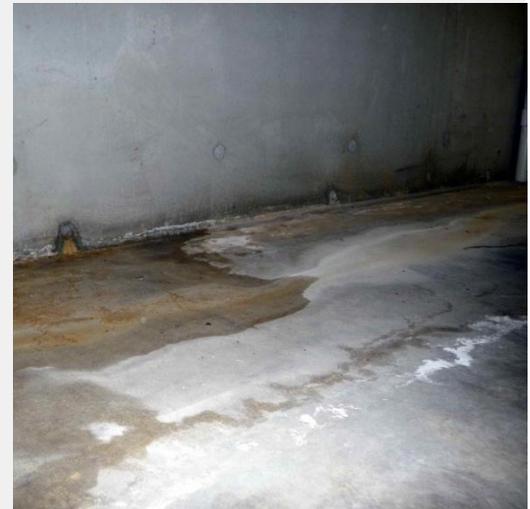
*Efflorescence is driven by hydrostatic pressure, and will continue to appear for as long as the source of moisture ingress is left unattended*

Efflorescence will cease when moisture through the concrete stops. This can only be achieved if appropriate and effective waterproofing is installed to prevent moisture entering the concrete. Once the waterproofing has been installed and checked, the existing efflorescence can be removed by a number of options. But before you start painting, here is a suggested procedure; it is a guide only, so please contact your Dulux<sup>®</sup> Protective Coatings Consultant for your particular project needs.

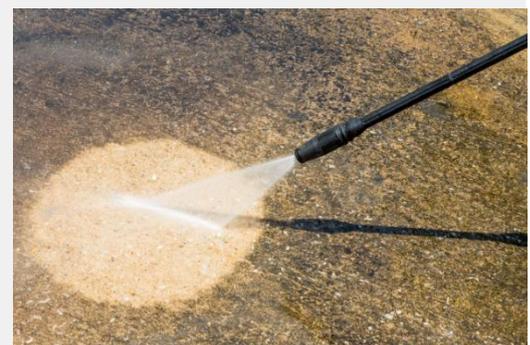
*High pressure water wash is an effective way of removing efflorescence, but introduces more moisture into the concrete.*

1. Ensure that the concrete has been cured for at least 30 days.
2. Remove all efflorescence, other surface contaminants and loose material. Any one of a number of techniques may be used, including, but not limited to, wire brushing (hand or power tool), dry abrasive blasting or high-pressure water jet. (The use of water will reintroduce some moisture into the concrete and can cause some reappearance of efflorescence. Allow concrete to dry, and wire brush any residual efflorescence.) Check for any reoccurring efflorescence, as this may indicate a leakage problem.

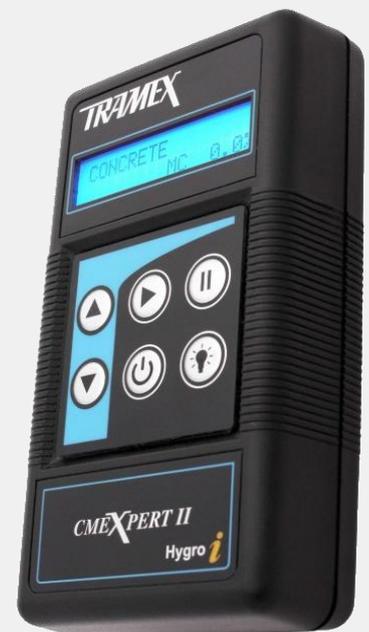
*A concrete moisture metre can help determine if the concrete is worth painting*

3. Check moisture content of concrete. This should be <10%, as measured with a standard moisture meter. If so, the concrete is ready to coat. If not, go to step 4.

6. Once all waterproofing measures have been carried out, allow the concrete to dry out and equilibrate. Recheck moisture content of concrete to ensure it is <10%, as measured with a standard moisture meter. If so, the concrete is ready to coat.
