PROTECTING AUSTRALASIA'S ASSETS

OUR MAINTENANCE SYSTEMS

OUR COATING SYSTEMS FOR NEW WORK

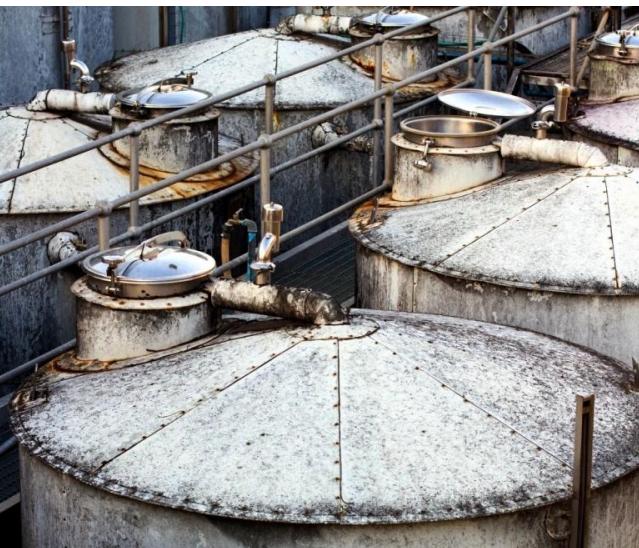
The cladding's zinc layer has corroded to white zinc oxide. Red rust shows where the zinc has been completely depleted.

"Duplex System" is simply another term for painted galvanised steel. The formation of powdery zinc corrosion products beneath the coating system is the major cause of coating failure.
