CONCRETE SPALLING

WHAT IS SPALLING?

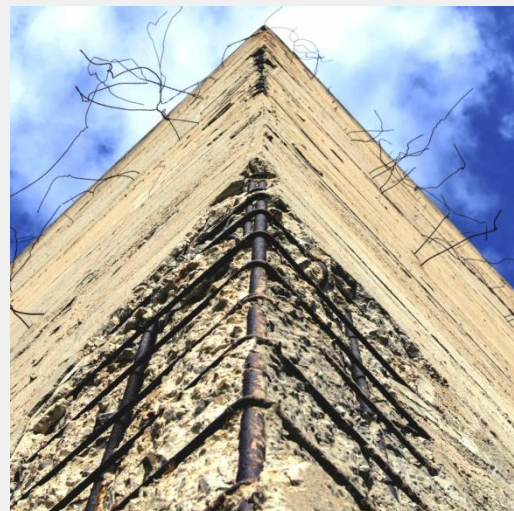
Rebars without adequate concrete cover nor protective anti-carbonation coating were left to corrode and caused catastrophic spalling.

When the embedded steel rebar corrodes, the corrosion products take up eight (8) times the volume of the original steel. This expansion within the concrete exerts a far greater force than the concrete’s flexural strength will allow, resulting in cracks in the concrete around the affected steel. The cracks expose the steel to further corrosion and cause more concrete breakdown.

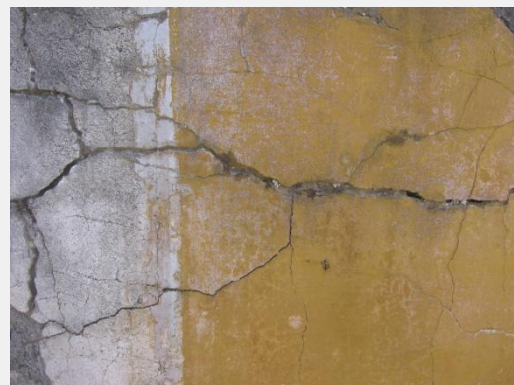
Deep cracks are the first signs of concrete spalling

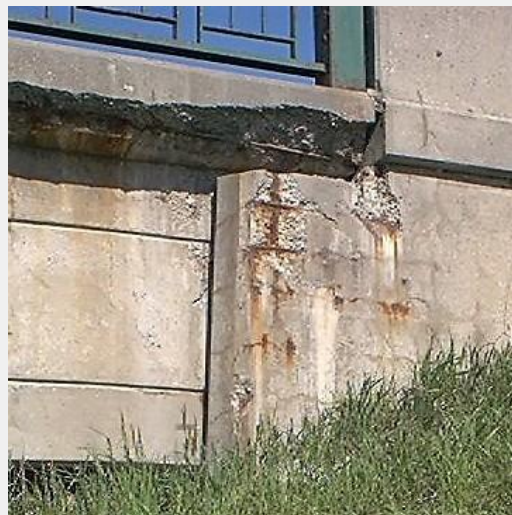
Low concrete cover and no protective coatings gave the rebars no protection from atmospheric acid attack

- Faulty concrete specification or design
- Incorrect placement of rebar and/or mesh, resulting in inadequate concrete coverⁱⁱ
- Poor site supervision during pouring, when the rebar is pushed too close to the surface of the concreteⁱⁱⁱ
- Lack of a protective “anti-carbonation” surface coating to prevent ingress of acidic chemicals

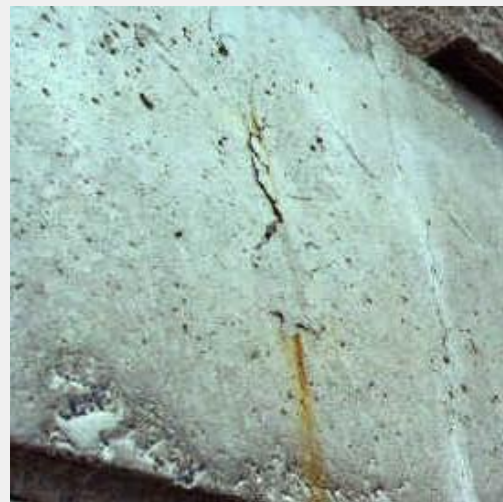
Spots of rust are no reason to panic! They are likely to be due to isolated steel impurities such as chair legs and tie wires, used to space out the steel rebars before the concrete is poured

No. Small steel bits such as tie wires and chair legs are often embedded near the surface of the concrete, and whilst corrosion of these small steel bits do not affect the integrity of the structure, they do look unsightly and rust stains can bleed through most applied finishes. They can be gouged out and the gouge filled with a cementitious repair mortar.

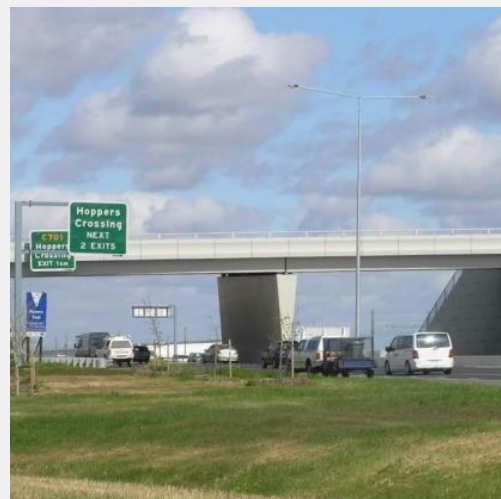
Vicroads specifies anti carbonation coatings for bridges, overpasses, sound barriers, and other steel-reinforced concrete structures
