Rating 1 rating after 6 years for internal steelwork

Bunnings Cannington Perth, WA

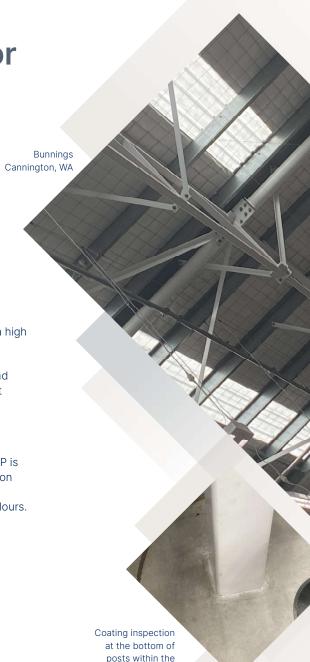
A full visual inspection at Bunnings Cannington found the coatings system to be in excellent condition, six years after the initial application.

There was no discolouration of the white topcoat, which had retained its high gloss finish.

There were isolated areas of delamination, due to items hitting against the steel or movement at the bottom of posts.

foot traffic area
